BANTAM LAKE FANWORT CONTROL PROJECT 2010

Prepared for:
Bantam Lake Protective Association

Prepared by:
Northeast Aquatic Research, LLC

Final Report

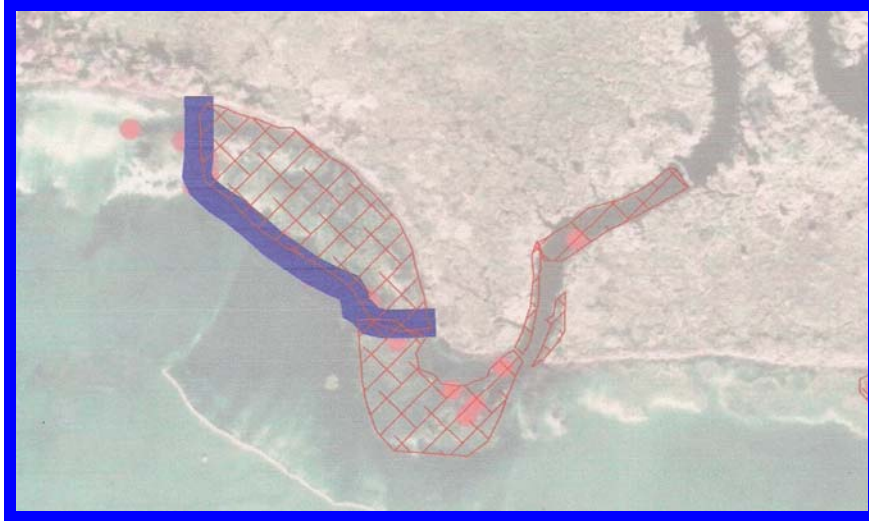
Containment fence, 666 feet long was installed along the outer edge of dense fanwort bed on July 14, 2010. Containment fence was removed on October 8, 2010.

The containment barrier had no affect on retaining fanwort. The plant was observed growing under the fence in a number of locations along its length, mostly toward the eastern end (closest to the mouth of the Bantam River). The barrier may have prevented human access into the dense fanwort beds contained within the bed but this was not noticed. Few anglers ventured close to the barrier due dense plant beds located outside of the barrier.

Location of containment fence as solid blue line 666 feet in length. Note the line in map below is shown wider than the actual fence for display purposes

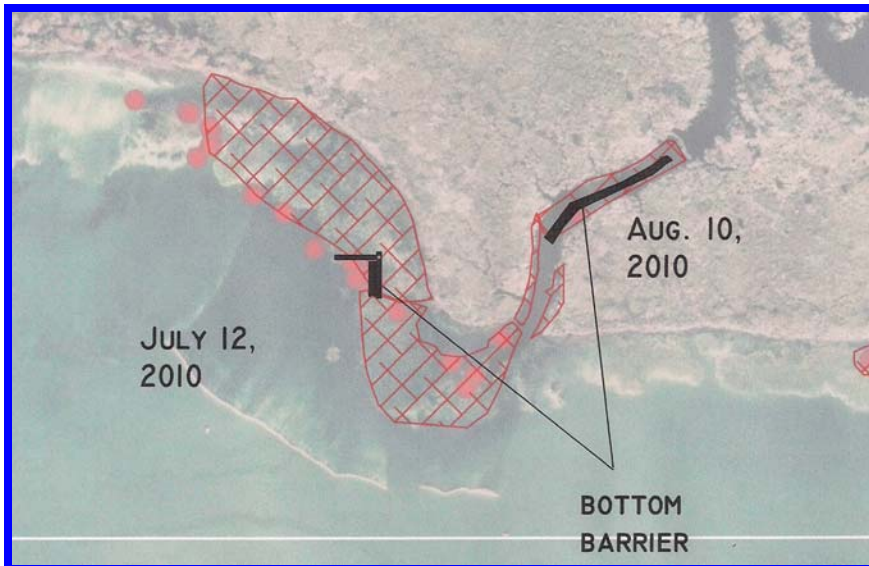
The goal was to experiment with Benthic Barriers as a method to control fanwort. Bottom Barrier (Aquascreen) was installed in two locations, 2.5 rolls were placed adjacent to the containment fence on July 14, 2010. The remaining 7.5 rolls were placed in the Bantam River on August 10, 2010.

Locations of Bottom Barrier Placement

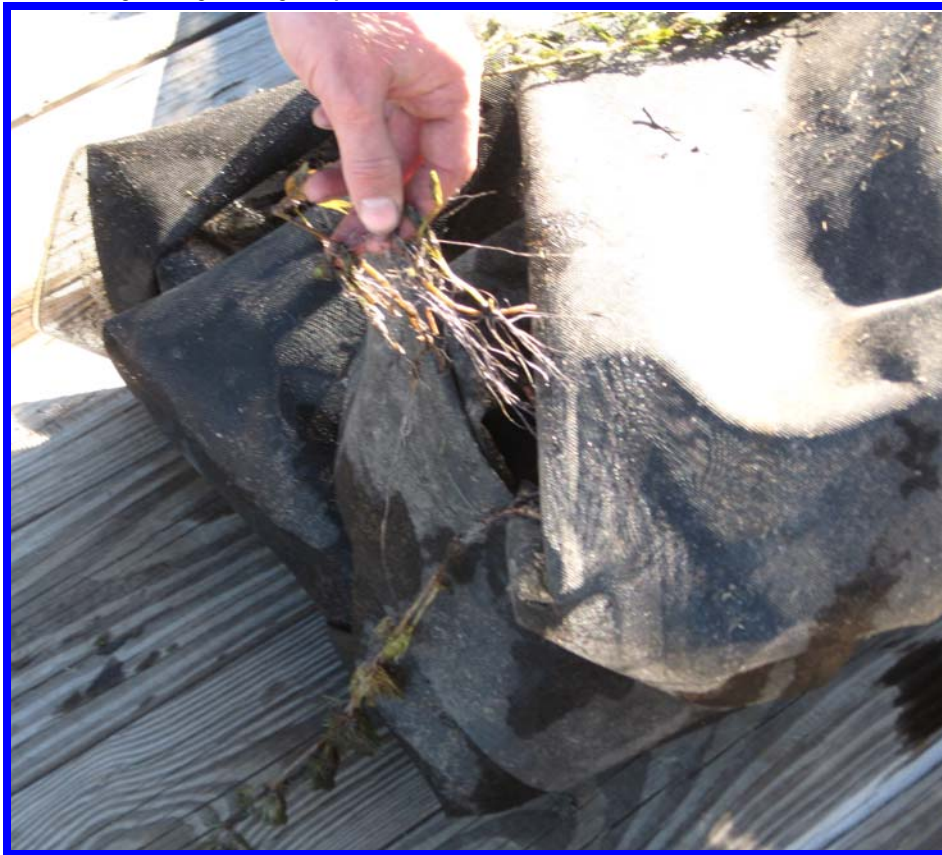
Benthic barrier (Aquascreen) proved to be affective at killing plants it covered. In each area barrier was placed over dense beds of 100% fanwort plants. All fanwort under the material appeared dead. However, all Aquascreen removed from the lake was found to have new fanwort plants growing on top of the material (see following photograph). Aquascreen placed in the river was 60 - 90 % covered with new fanwort plants that rooted through the material. These plants were fragments that had been carried down river and settled on the Aquascreen.

Although Aquascreen could be used to kill existing plants, it will not work to keep areas fanwort free because fragments will settle and root though the material. It may be possible to use the Aquascreen in order to remove plants that grow during the season by allowing fragments to grow on the material and than remove the material at the end of the year.

Fanwort roots growing through Aquascreen

Bottom Barrier was affective at killing plants it covered but it proved to be an excellent rooting surface for fanwort fragments. The large number of newly rooted fragments on the aquascreen below the beaver dam in the Bantam River indicates the severity of fragmentation of fanwort growing in the river.

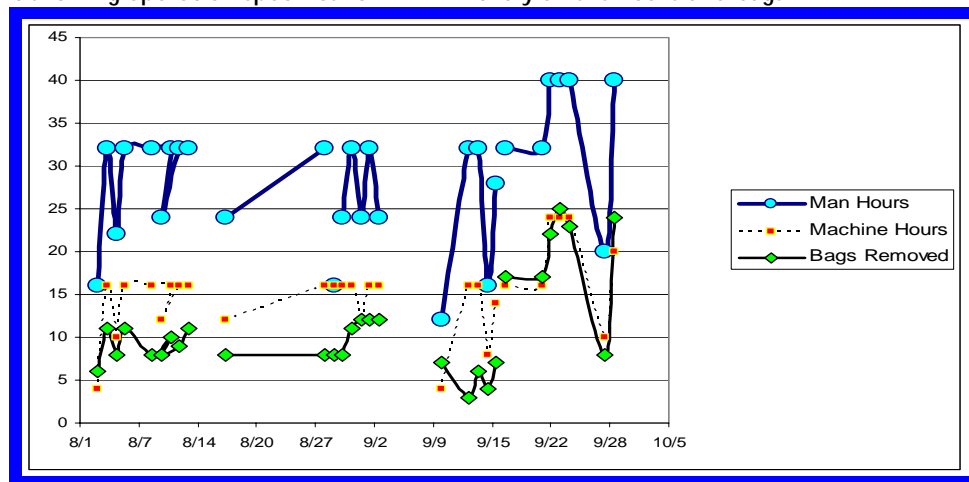
Chart showing operation specifics for WERM - the y axis is hours and bags
