**Bantam Lake
Litchfield, CT
State Listed Aquatic Plant Survey
2025**

Prepared for the Bantam Lake Association

December 31, 2025

Gregory J. Bugbee and Riley S. Doherty

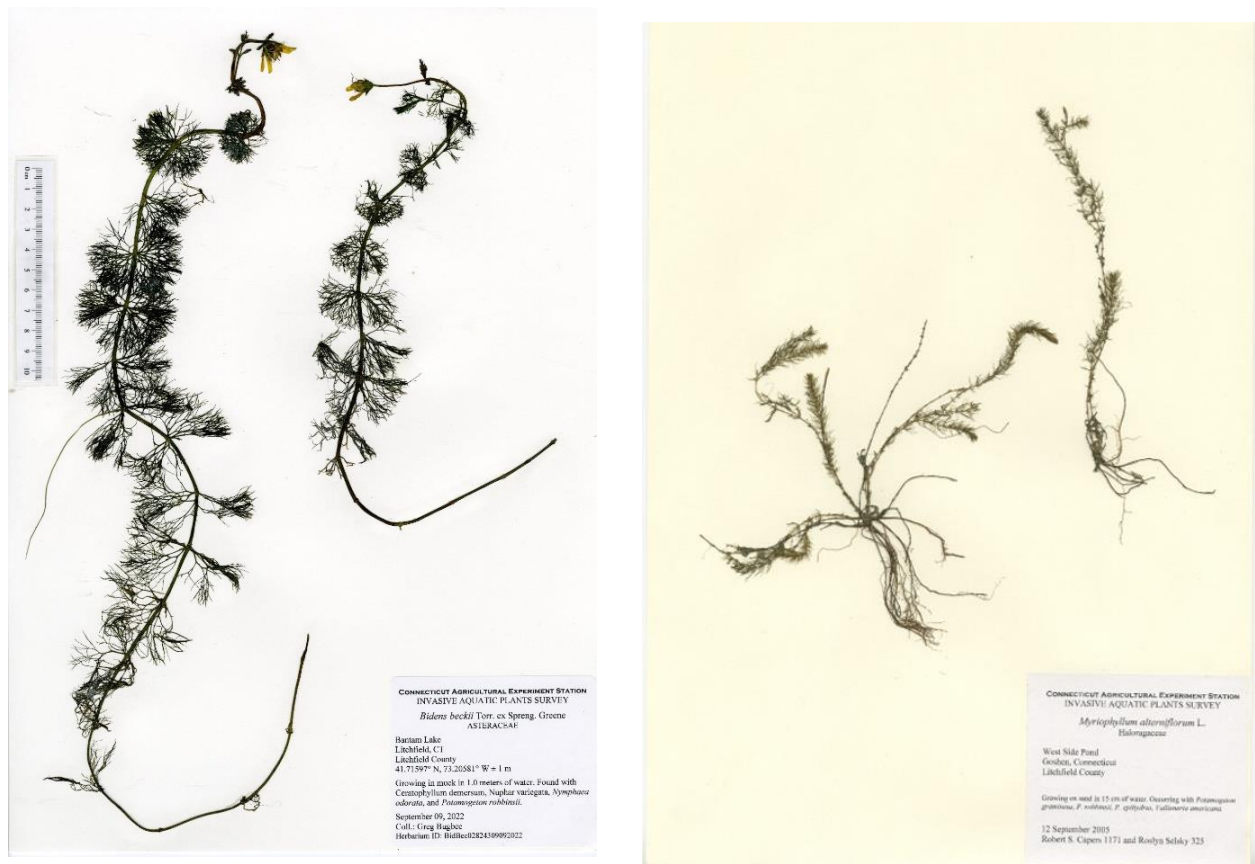
Figure 1. Herbarium mounts of the state listed species water marigold (left) obtained in 2022 from Bantam Lake and slender watermilfoil (right) obtained in 2005 from West Side Pond.

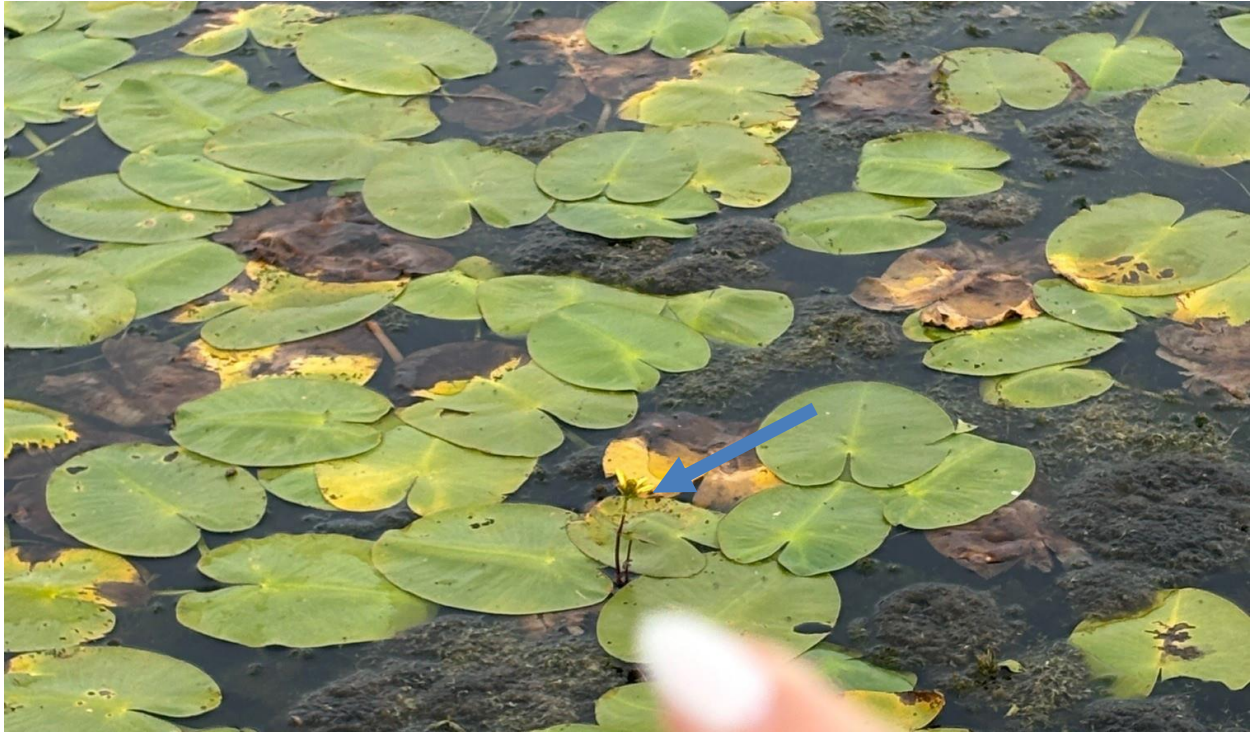
Figure 5. Water marigold in Bantam Lake’s North Cove in 2025. Blue arrow points to emersed flower.

Notable features of water marigold include a yellow flower and opposite fanlike foliage that does not have an elongated petiole like the often-comingled invasive fanwort. Features of alternate watermilfoil that distinguishes it from other watermilfoils is alternate flowers on emersed spikes. The shallow water habitat for these species was often covered with dense vegetation such as white and yellow waterlily (*Nymphaea odorata*, *Nuphar varigata*) (Figure 5). In northern Outlet Cove of Bantam Lake, the vegetation was so dense it limited our access. This increased the chances that species could be missed. Water clarity during this survey ranged from 3 – 6 feet (1 – 2 m) which was adequate to see most plants.

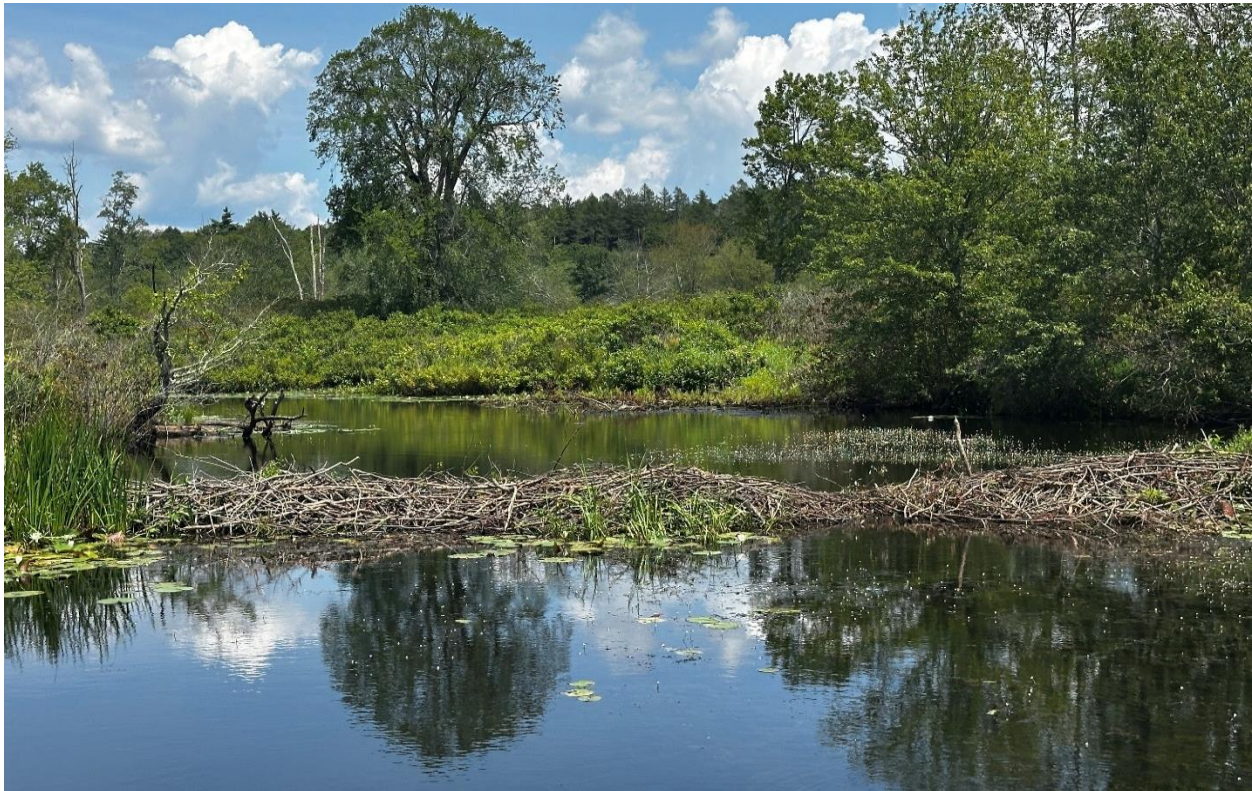
Figure 6. Southernmost of three beaver dams along the Bantam River affecting habitat and making upstream access by boat difficult.

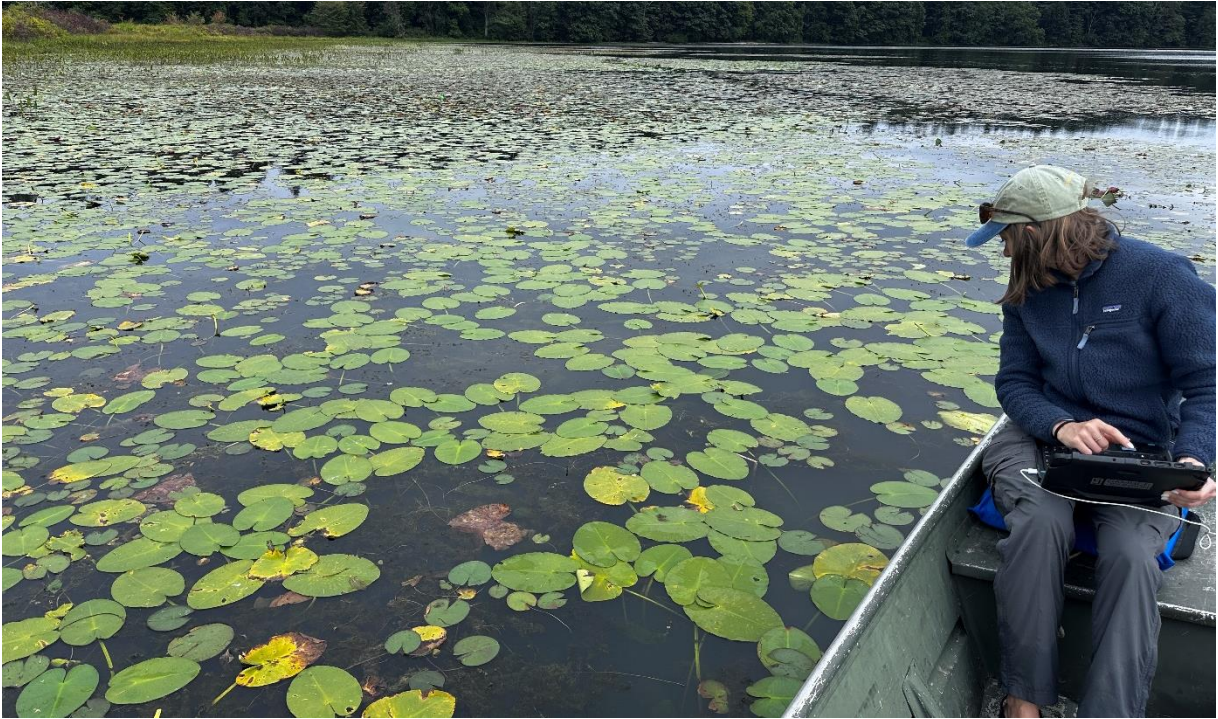
Water marigold in flower in Bantam Lake mixed with white/yellow waterlily

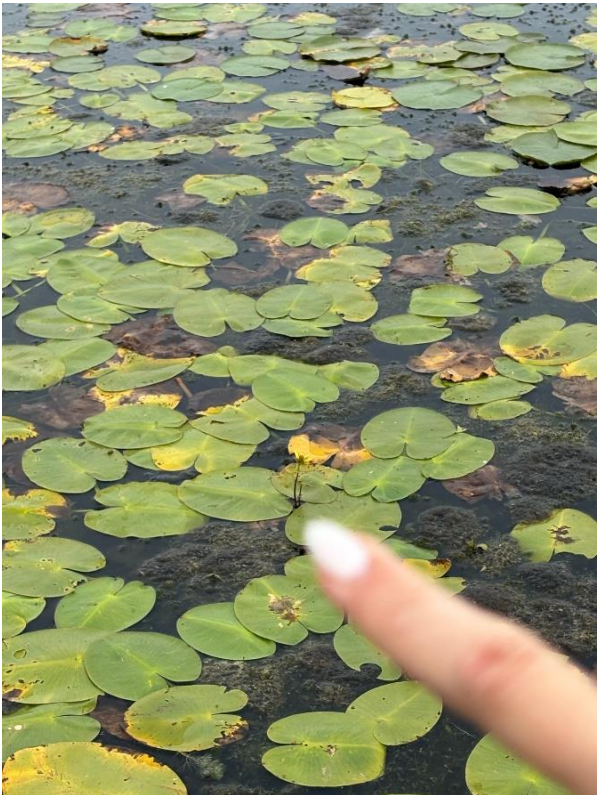
Locations of Water Marigold in Keeler Cove and North Bay

Bidens beckii Locations
